COMPANY OVERVIEW

Since its opening in late 2024, the childcare educational facility was experiencing unusually high utility costs—some exceeding \$8,000 per month. A renown commercial real estate agency, on behalf of the school and property owner Alicia, engaged Melink to investigate and correct the issue.

CHALLENGE

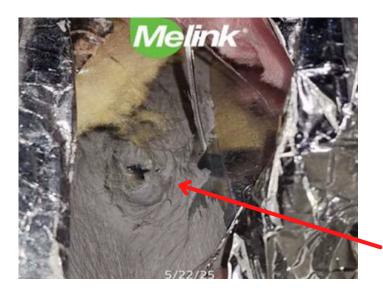
Return duct for this RTU was incomplete. The diffuser was not installed.
